**STRUCTURAL SYSTEMS
RESEARCH PROJECT**

Report No.
SSRP - 97/17

**EXPERIMENTAL INVESTIGATION OF
DUCTILITY OF IN-GROUND HINGES IN
SOLID AND HOLLOW PRESTRESSED
PILES**

Final Report on a Research Project funded by Caltrans under
Contract No. DOT 59V375

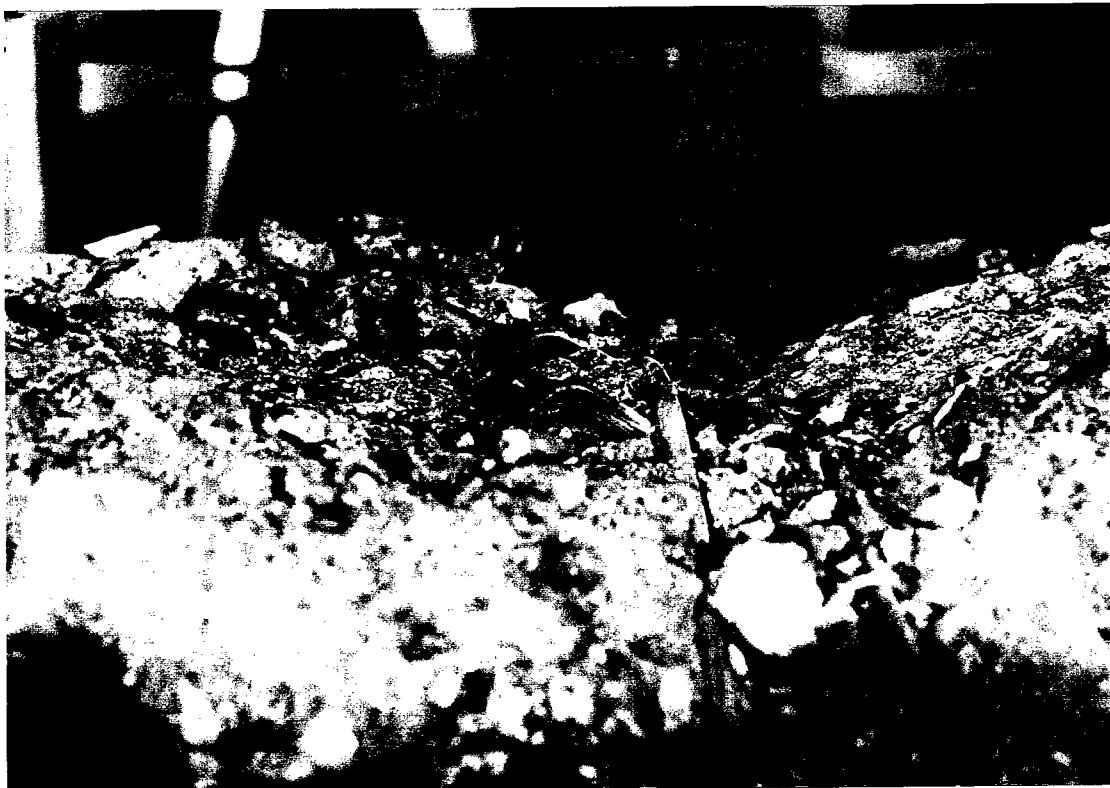
Fig. 6.2.2: Hollow pile PS12, buckled prestressing tendons (medium reinforcement, plastic hinge unconfined)

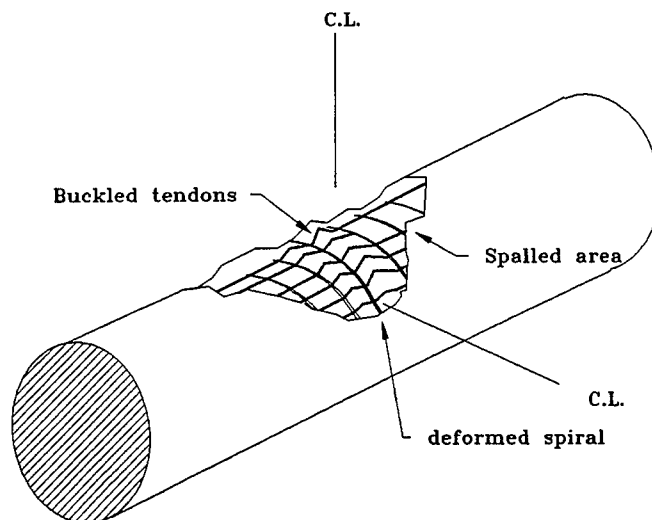
Fig. 6.2.3: Spalling and tendon buckling on hollow pile test unit PS12 (medium reinforcement, plastic hinge unconfined)

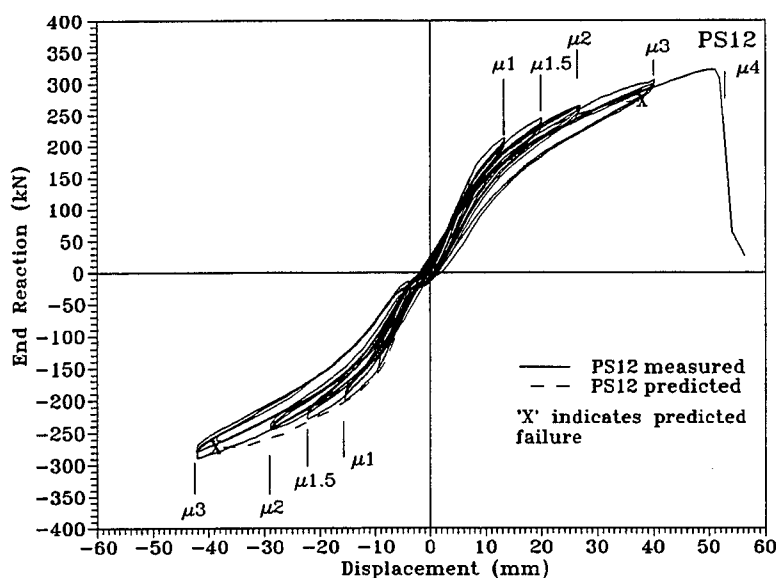
Fig. 6.2.4: Force-displacement hysteresis loops for hollow pile shaft test unit PS12 (medium reinforcement, plastic hinge unconfined)

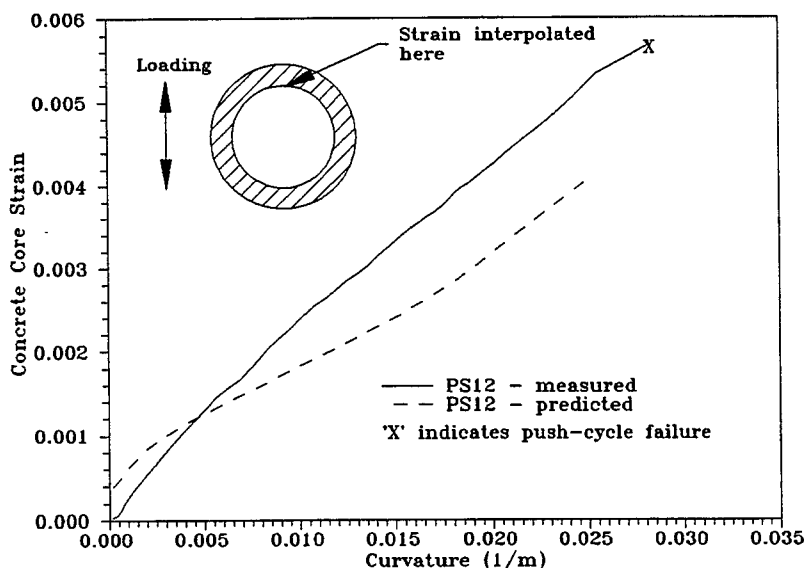
Fig. 6.2.5: Interpolated critical section core strain envelope vs. curvature for hollow pile shaft test unit PS12, push cycles (medium reinforcement, plastic hinge unconfined)

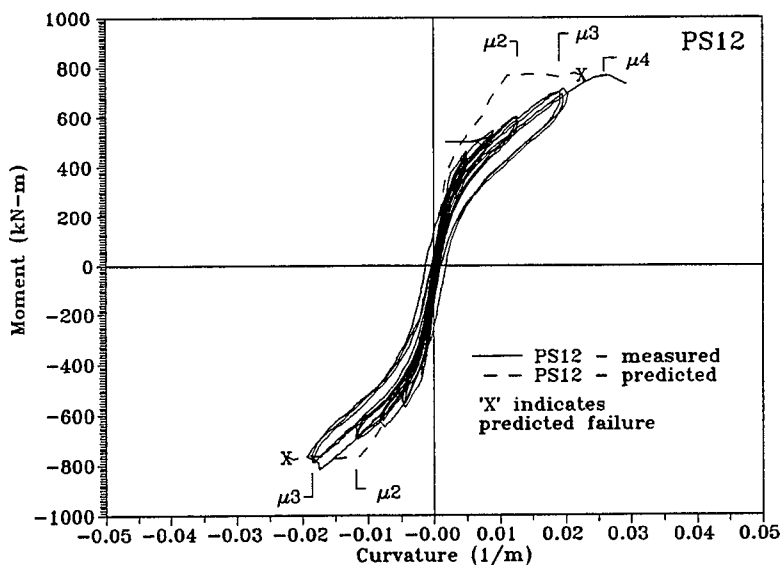
Fig. 6.2.6: Moment-curvature hysteresis loops at longitudinal midpoint, hollow pile PS12 (medium reinforcement, plastic hinge unconfined)

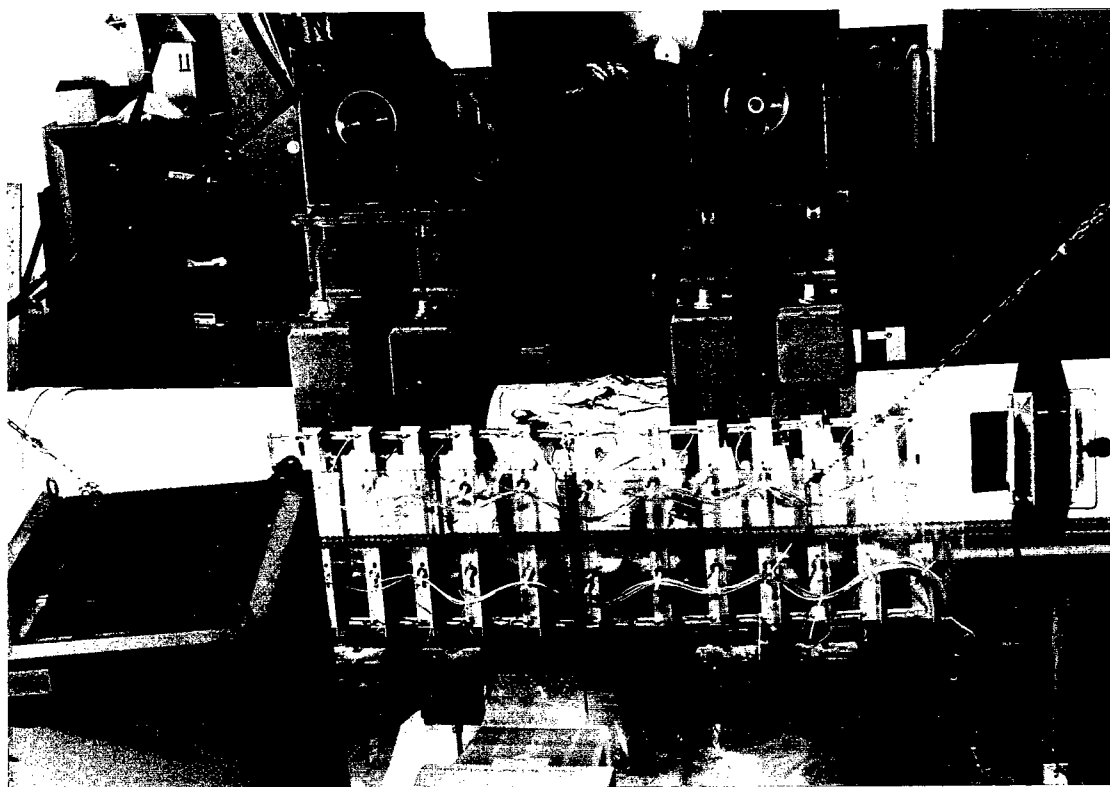
Fig. 6.3.1: Initial compression failure of hollow pile PS13 (medium reinforcement, plastic hinge unconfined, dowels in p.h. region)

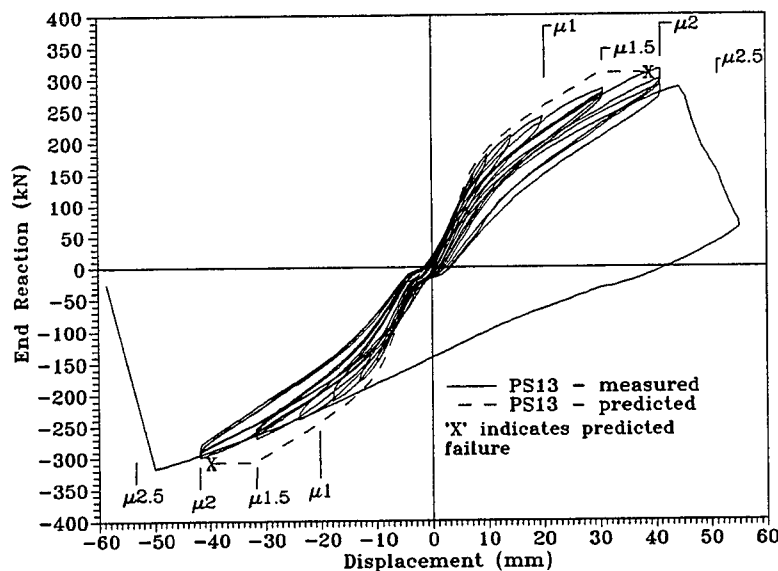
Fig. 6.3.3: Force-deflection hysteresis loops for hollow pile shaft test unit PS13 (medium reinforcement, plastic hinge unconfined, dowels in p.h. region)

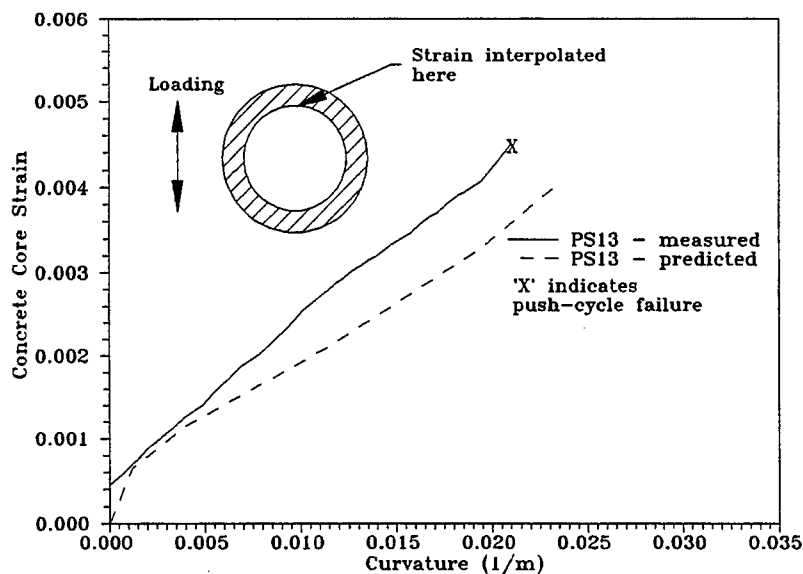
Fig. 6.3.4: Interpolated critical section core strain envelope vs. curvature for hollow pile shaft test unit PS13, final push cycle (medium reinforcement, plastic hinge unconfined, with mild steel dowels in p.h. region)

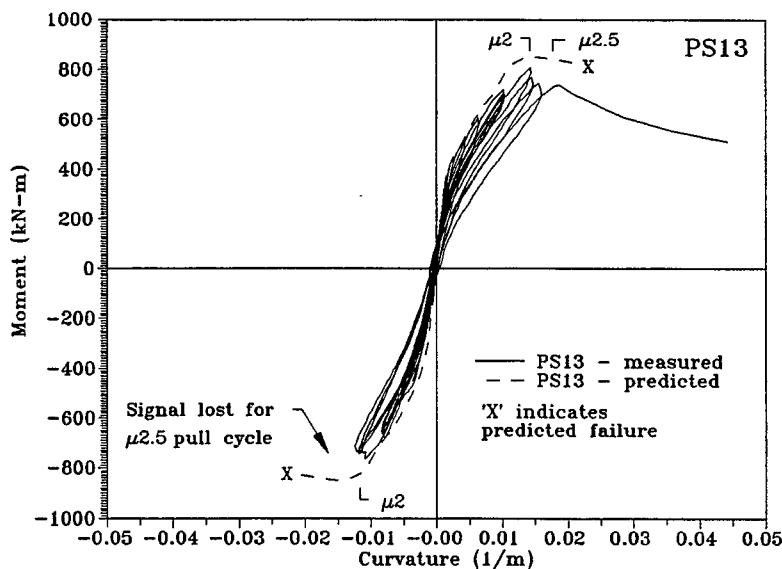
Fig. 6.3.5: Moment-curvature hysteresis loops at test unit midpoint, hollow pile PS13 (medium reinforcement, plastic hinge unconfined, with mild steel dowels in p.h. region)

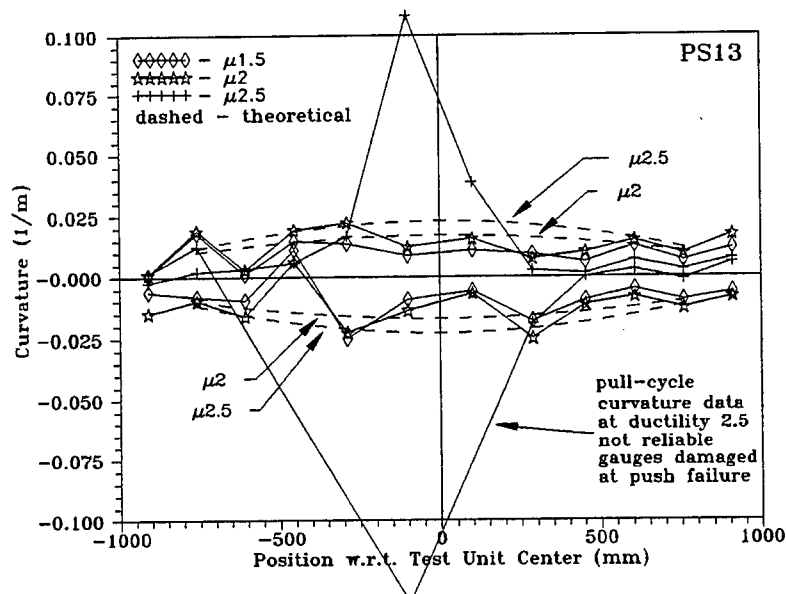
Fig. 6.3.6: Curvature profiles, hollow pile PS13 (medium reinforcement, plastic hinge unconfined, with mild steel dowels in p.h. region)

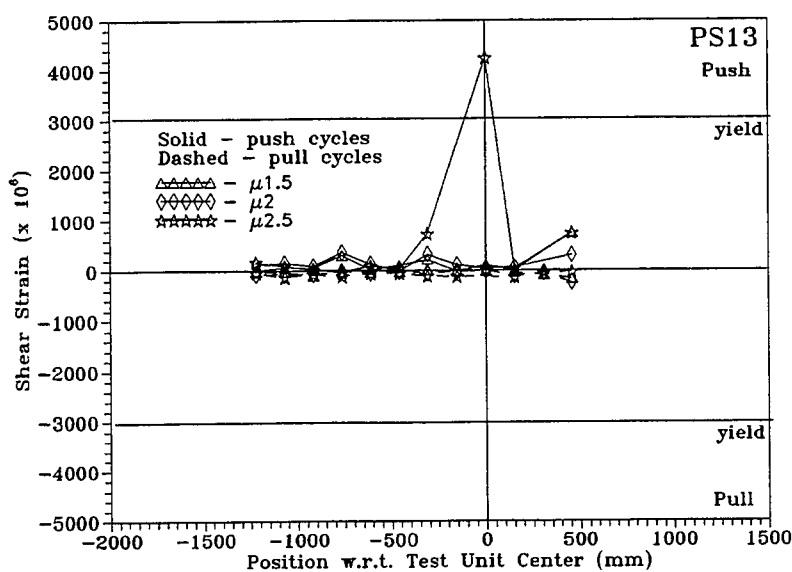
Fig. 6.3.7: Confining steel strains, hollow pile PS13 (medium reinforcement, plastic hinge unconfined, with mild steel dowels in p.h. region)

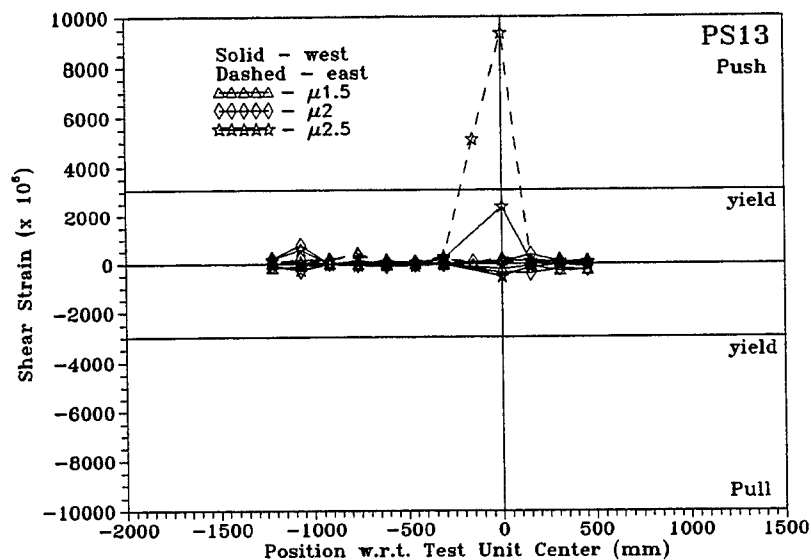
Fig. 6.3.8: Shear steel strains, hollow pile PS13 (medium reinforcement, plastic hinge unconfined, with mild steel dowels in p.h. region)

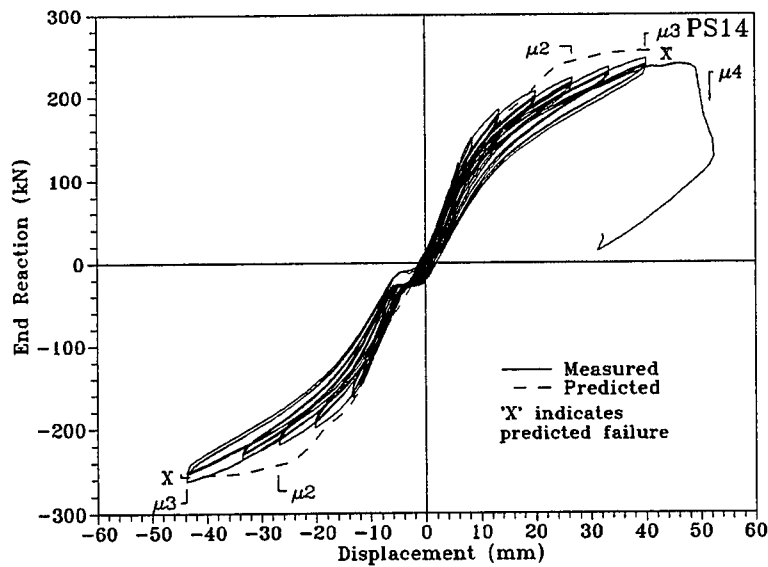
Fig. 6.4.2: Force-displacement hysteresis loops for hollow pile shaft test unit PS14 (light reinforcement, plastic hinge confined)

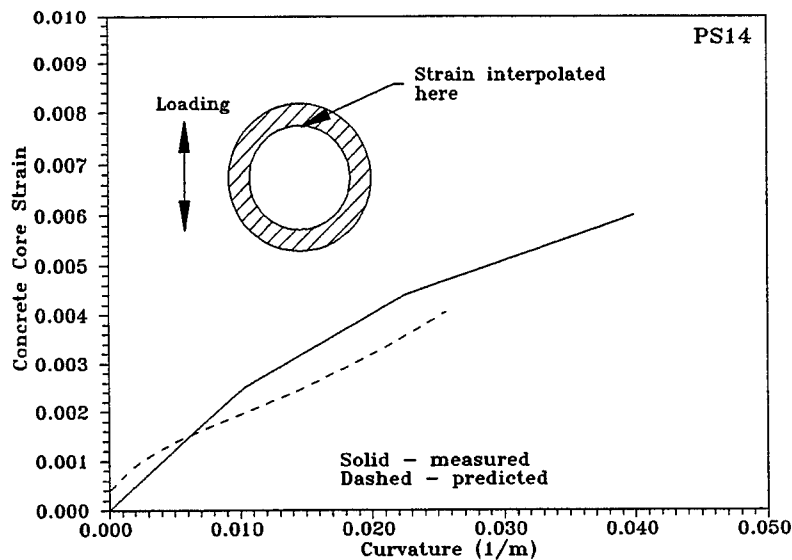
Fig. 6.4.3: Interpolated critical section core strain envelope vs. curvature for hollow pile shaft test unit PS14, push cycles (light reinforcement, plastic hinge confined)

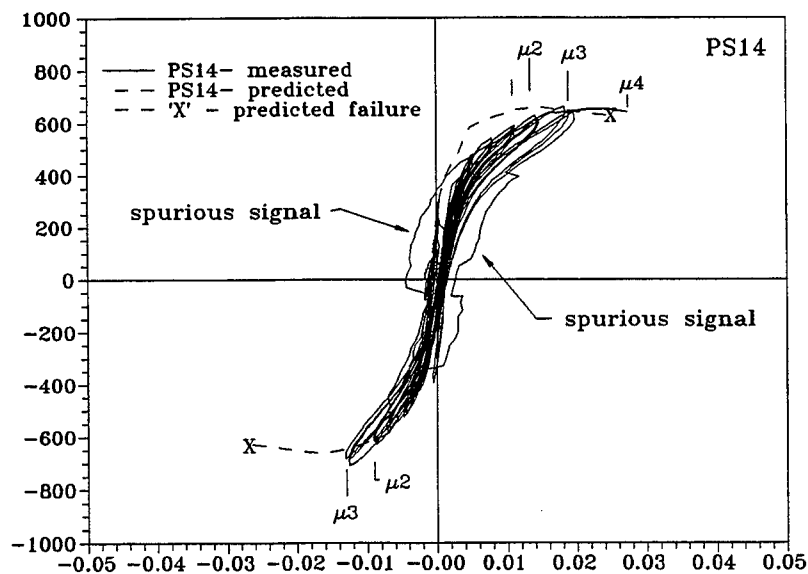
Fig. 6.4.4: Moment-curvature hysteresis loops at longitudinal midpoint, hollow pile PS14 (light reinforcement, plastic hinge confined)

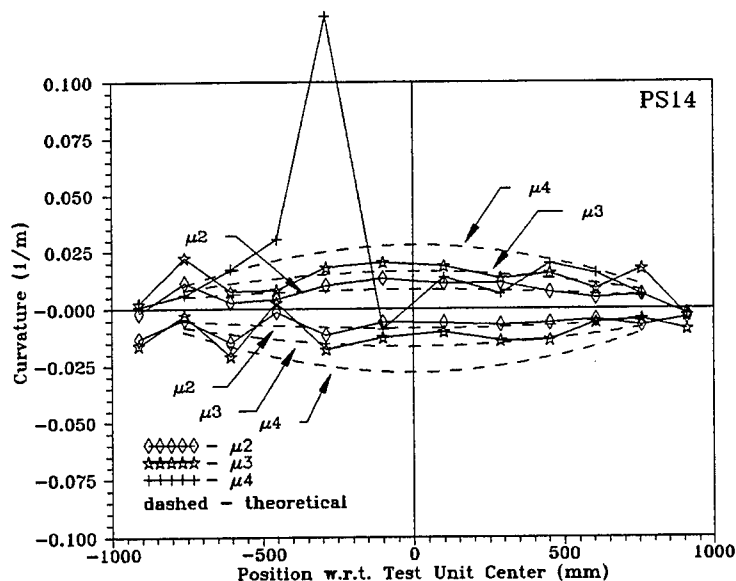
Fig. 6.4.5: Curvature profiles, hollow pile PS14 (light reinforcement, plastic hinge confined)

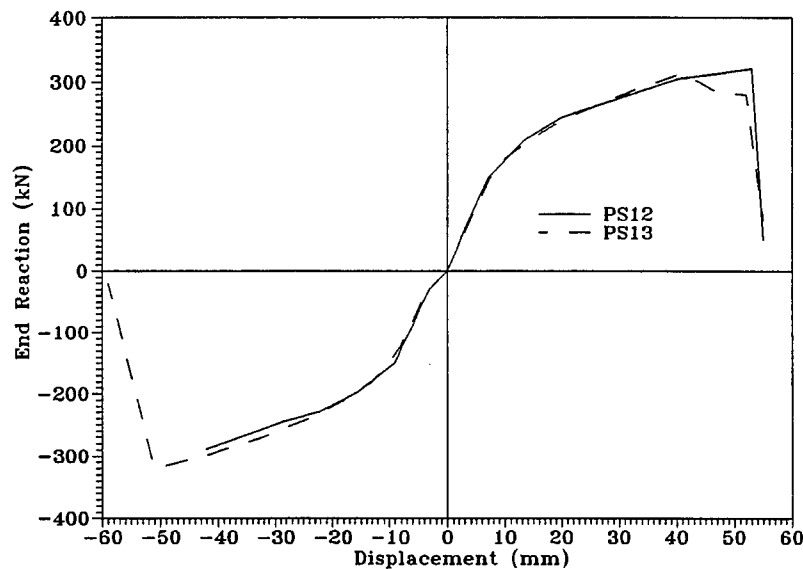
Fig. 6.5.3: Comparison of force-displacement envelopes, PS12 (no nonprestressed reinforcement in plastic hinge region) and PS13 (with nonprestressed longitudinal reinforcement in plastic hinge region)

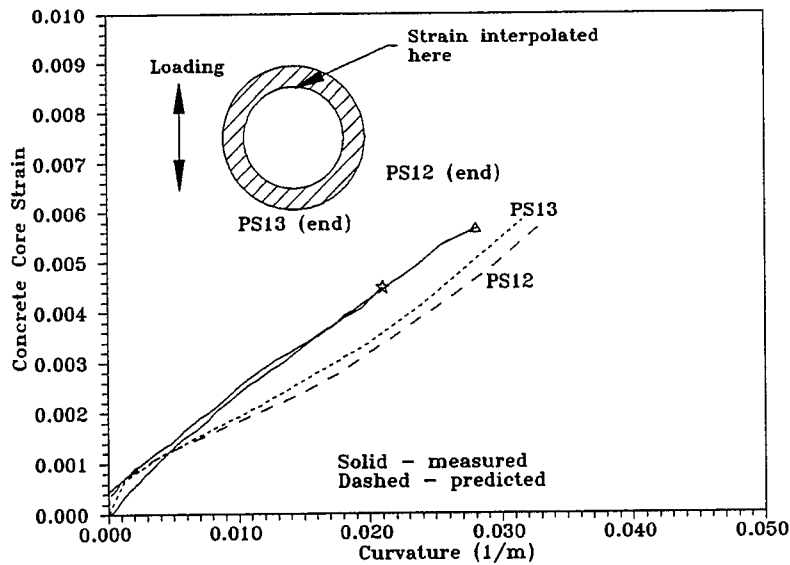
Fig. 6.5.4: Comparison of core strain, PS12 (no nonprestressed reinforcement in plastic hinge region) and PS13 (with nonprestressed longitudinal reinforcement in plastic hinge region)

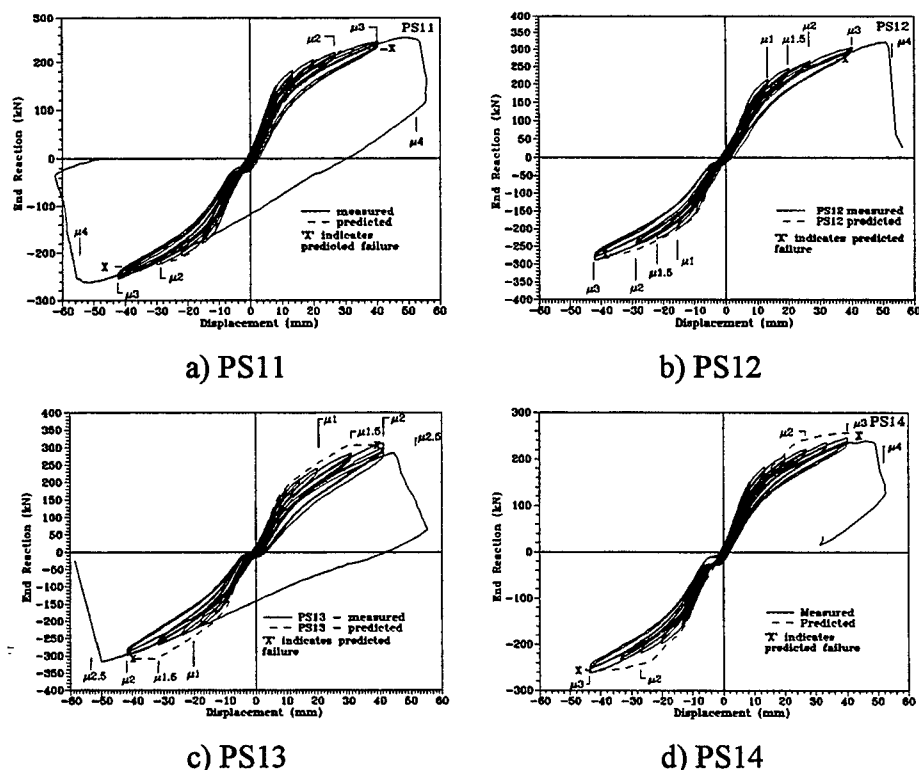
Fig. 6.6.5: Comparison of force-displacement hysteresis loops for hollow piles PS11 - PS14: a) PS11 (heavy reinforcement, plastic hinge confined); b) PS12 (medium reinforcement, plastic hinge unconfined); c) PS13 (medium reinforcement, plastic hinge unconfined, Gr. 60 bars in p.h.); d) PS14 (light reinforcement, plastic hinge confined)

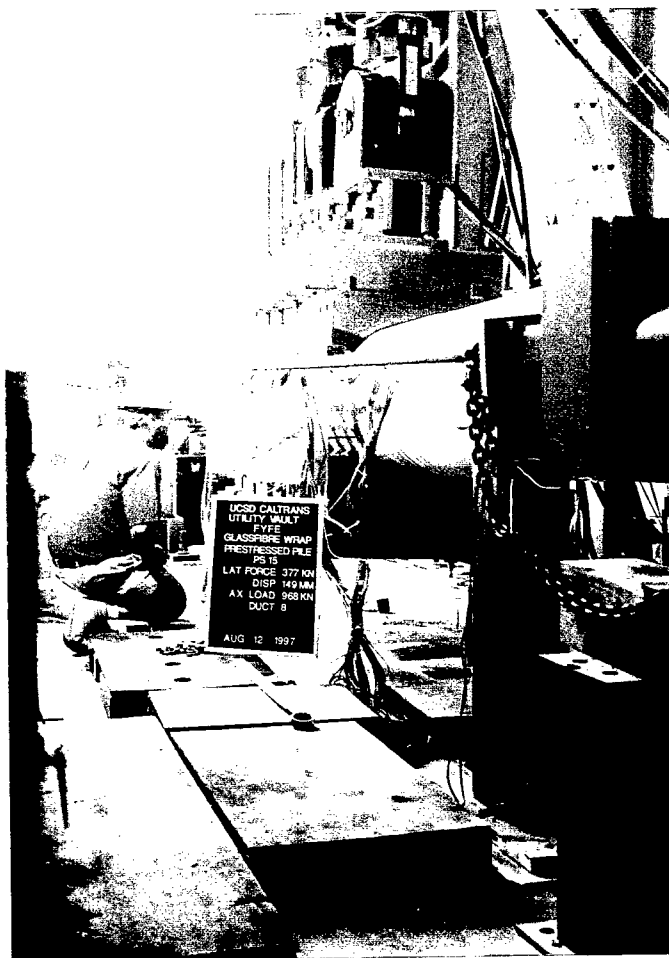
Fig. 7.1.1: Pile shaft test unit PS15 at $\mu=8$ (low reinforcement, glassfibre-jacketed, jacket uncut)

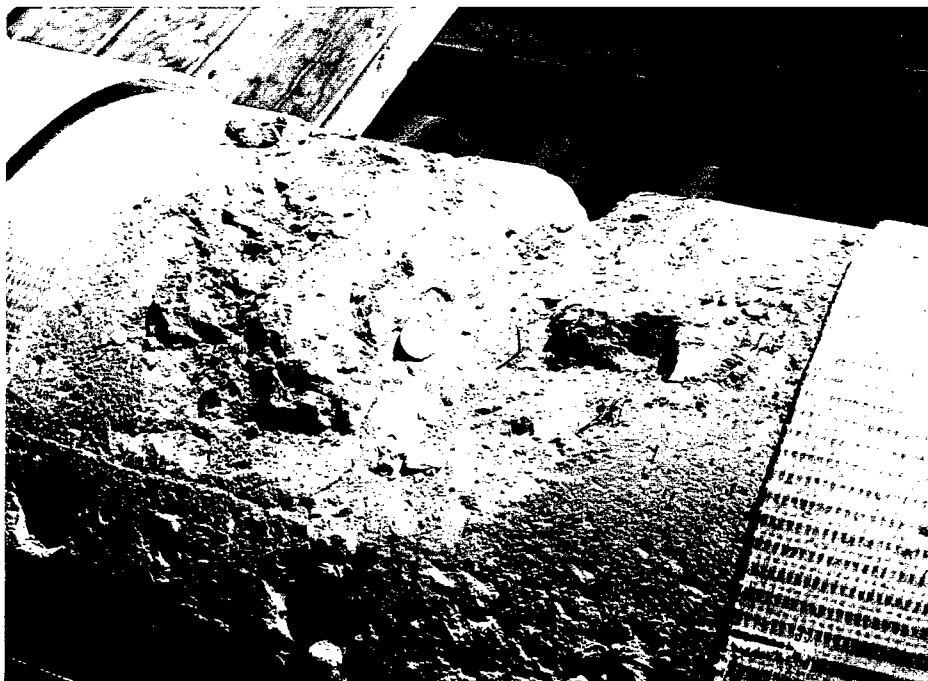
Fig. 7.1.3: Jacket removed from PS15's pull-cycle compression side; note "notch" where concrete has been crushed and has powdered away (low reinforcement, glassfibre-jacketed, jacket uncut)

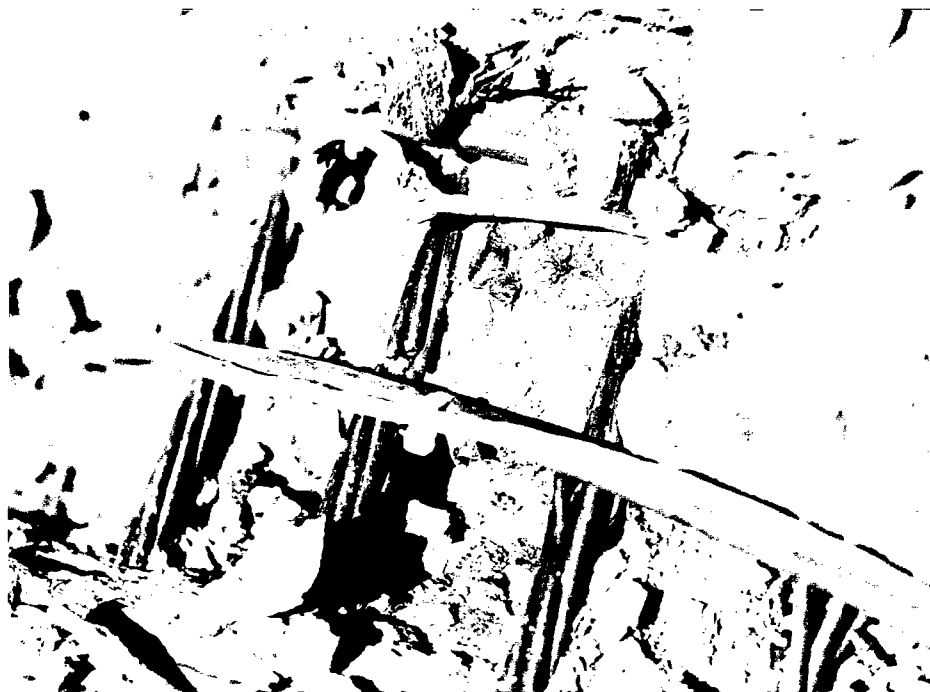
Fig. 7.1.4: Ruptured and buckled tendons, PS15 (low reinforcement, glassfibre-jacketed, jacket uncut)

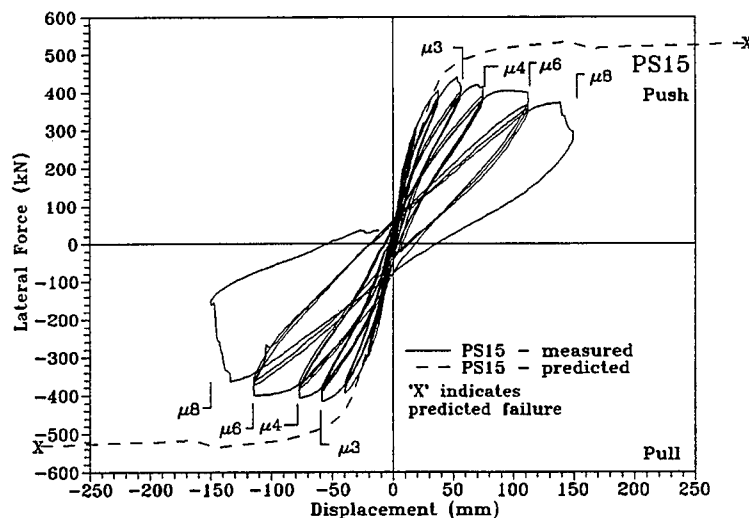
Fig. 7.1.5: Force-displacement hysteresis loops for pile shaft test unit PS15 (jacket uncut, plastic hinge confined)

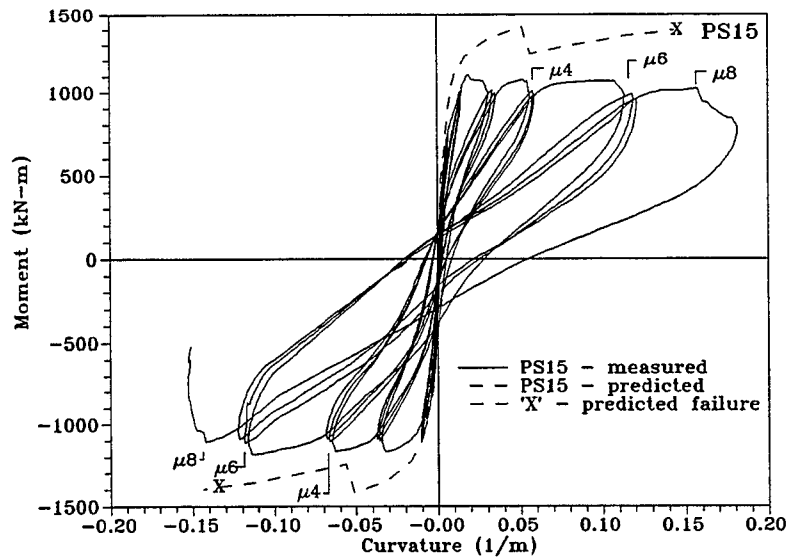
Fig. 7.1.6: Moment-curvature hysteresis loops (at longitudinal midpoint) for glassfibre-jacketed prestressed pile PS15 (jacket uncut, plastic hinge confined)

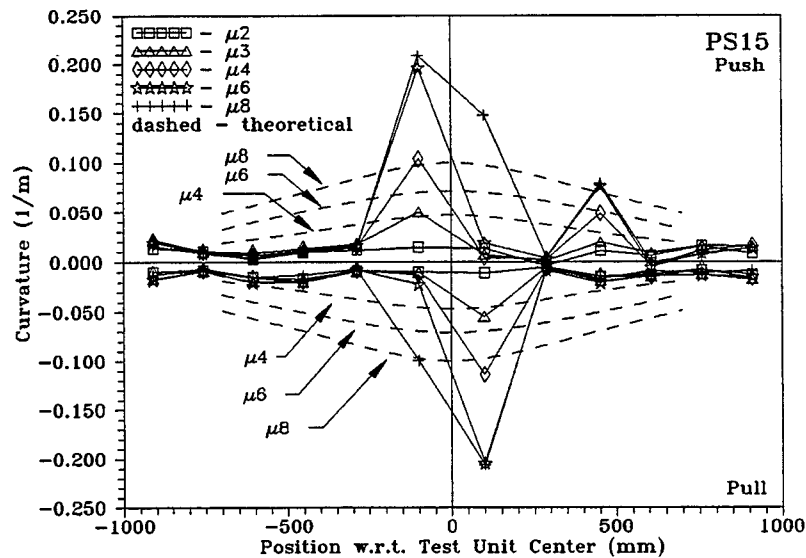
Fig. 7.1.7: Curvature profiles for glassfibre-jacketed prestressed pile PS15 (jacket uncut, plastic hinge confined)

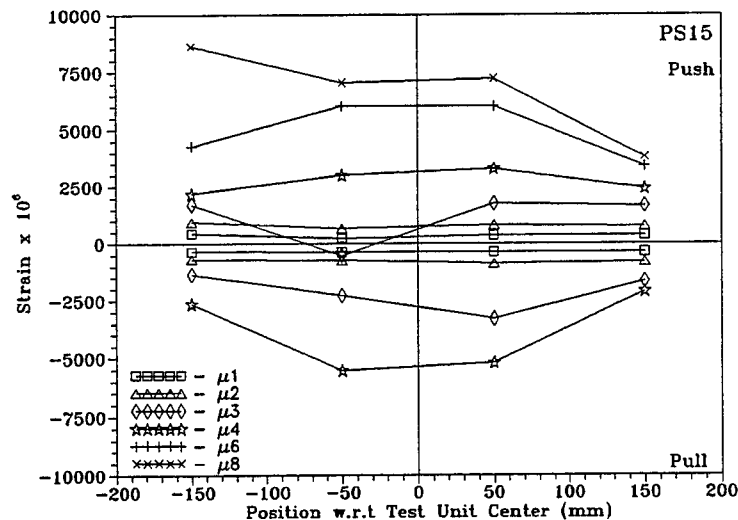
Fig. 7.1.8: Glassfibre jacket confining strains, PS15 (jacket uncut, plastic hinge confined)

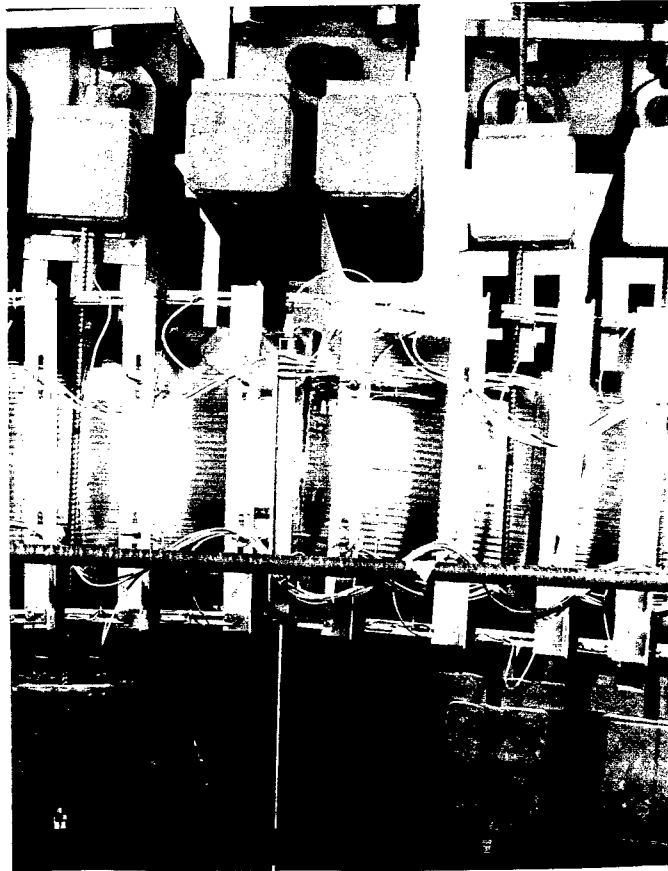
Fig. 7.2.1: Pile shaft test unit PS16 at $\mu=8$, showing flexure crack in jacket (glassfibre jacket with transverse cuts, plastic hinge unconfined)

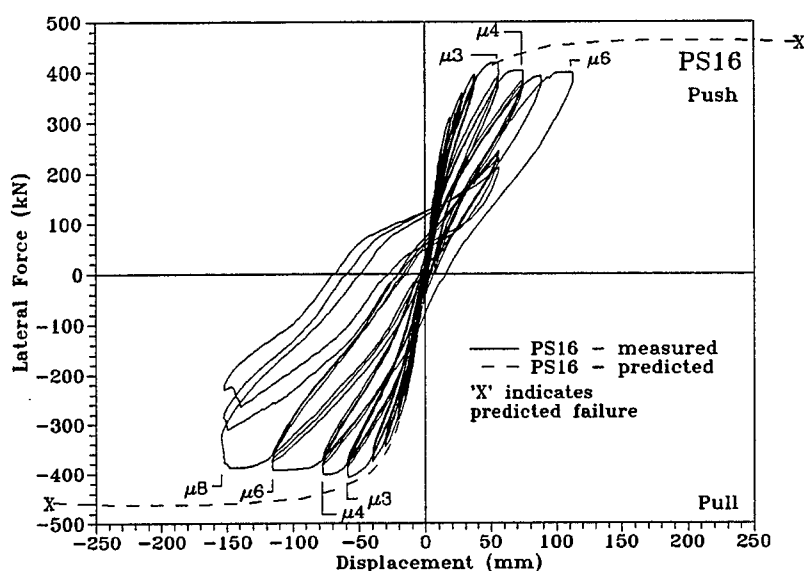
Fig. 7.2.3: Force-displacement hysteresis loops, pile shaft test unit PS16 (glassfibre jacket with transverse cuts, plastic hinge unconfined)

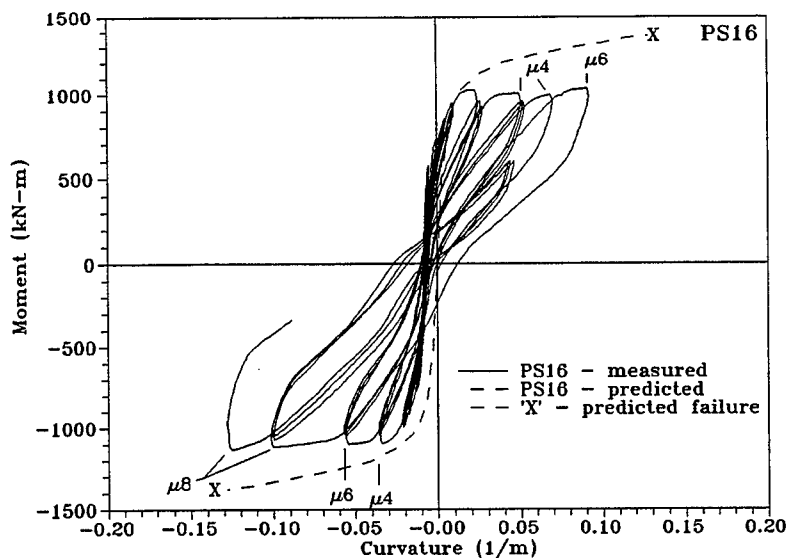
Fig. 7.2.4: Moment-curvature hysteresis loops, PS16 (glassfibre jacket with transverse cuts, plastic hinge unconfined)

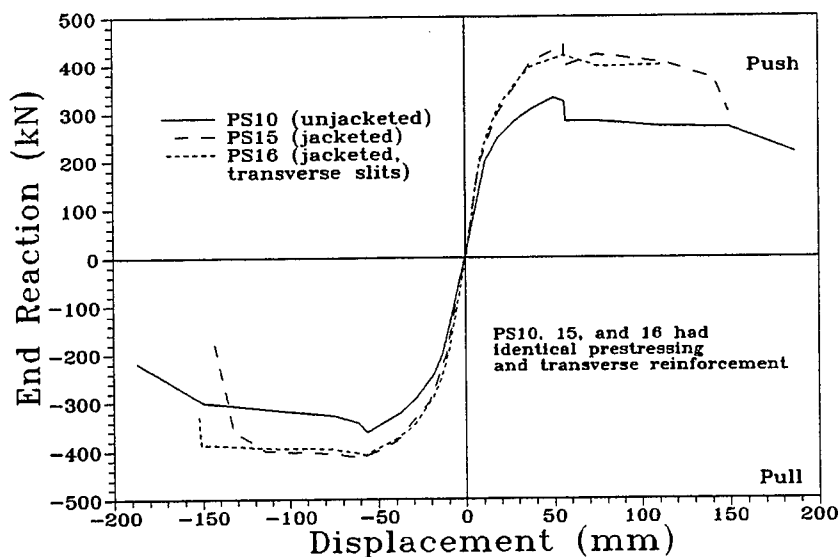
Fig. 7.3.1: Force-displacement envelopes, PS10, PS15, and PS16

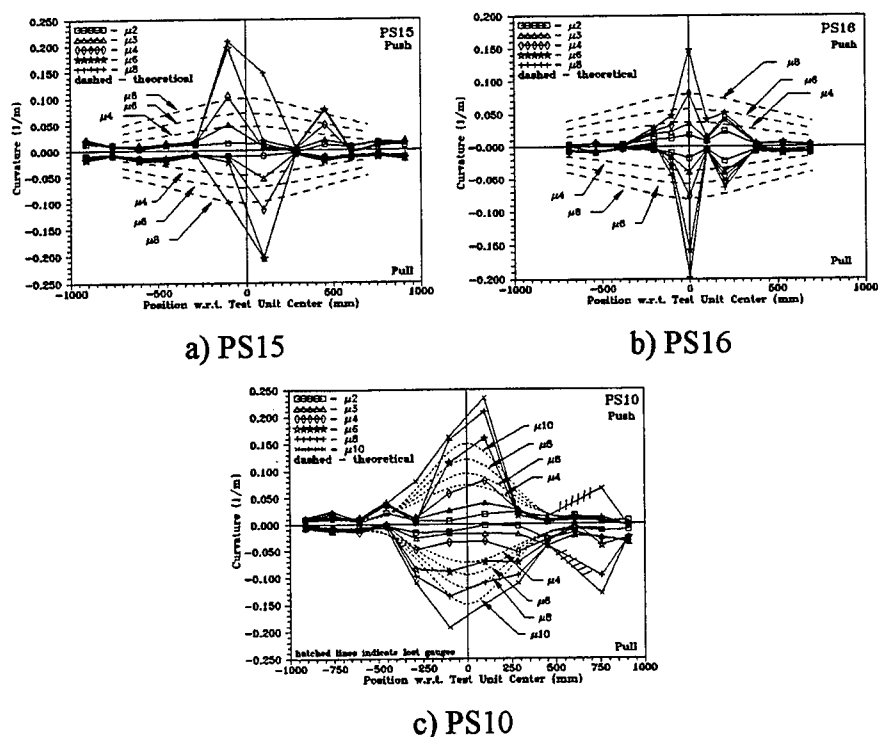
Fig. 7.3.2 : Comparison of curvature profiles: a) PS15 (glassfibre jacket, plastic hinge confined); b) PS16 (glassfibre jacket w/transverse slits, plastic hinge unconfined); c) PS10 (unjacketed, plastic hinge confined)...all had transverse reinforcement $\rho_t=0.005$
